# RESERVE FUND STUDY

**1049 South Park Street**

Halifax County Condominium Corporation No. 144

March 12<sup>th</sup>, 2025

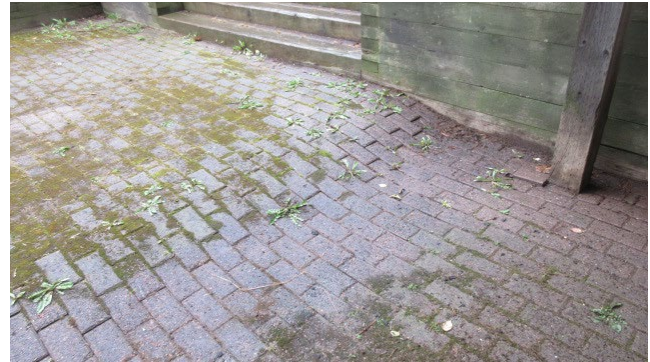
There is considerable settlement in the courtyard at the edge of the shelter, which is also the edge of the parking structure below: this is a potential tripping hazard (photo).

Provide a planter box or other barrier where there is an abrupt grade change, as part of general maintenance or using the **Site Contingency Allowance** below, for 28% of the total cost of local repairs to the courtyard landscaping, based on existing cost-sharing agreements.

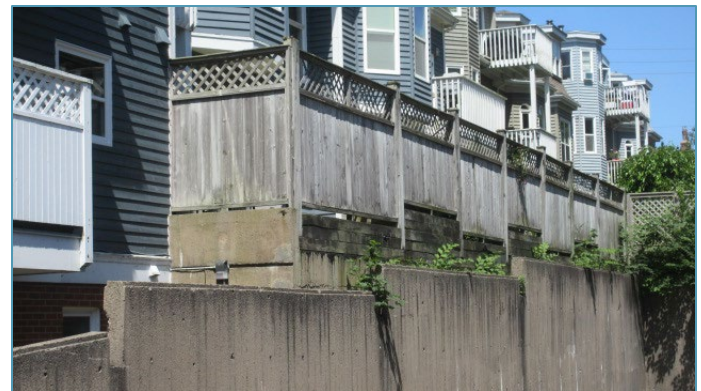
The fence is in fair condition, with deterioration of wood. The remaining useful life is assessed to be 5-15 years.

Budget for replacing approx. 120' of privacy fence in 2034.

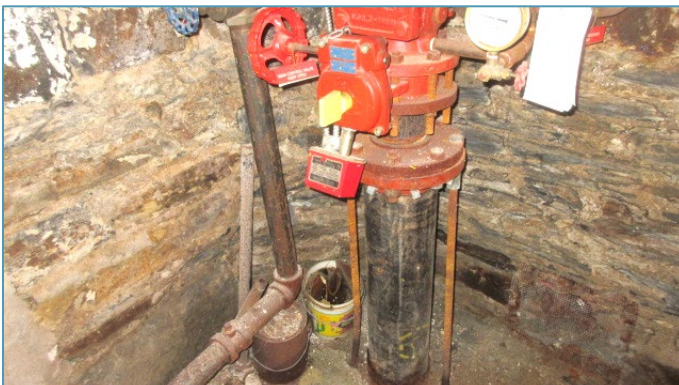
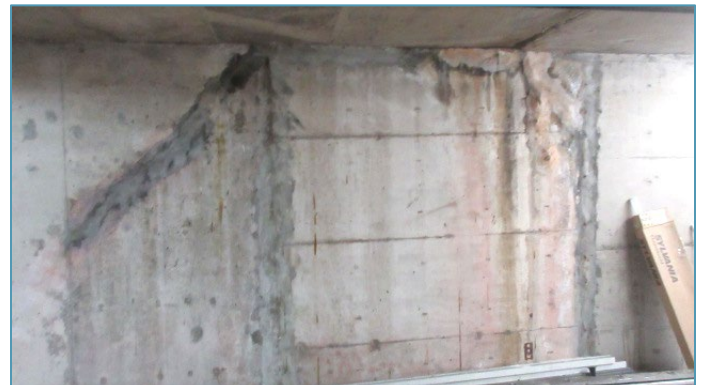
Stone foundations are serviceable but a source of moisture in the Basement Level, resulting in deterioration of mechanical services. Ventilation improvements and/or foamed-in-place insulation may reduce this issue and is included in the **Structure – Contingency Allowance** below.

Concrete retaining walls are, in general, in good condition. A crack in the wall at the northeast corner is a source of water ingress, with little change in the last five years.

1. Re-inject the wall crack. (Alternatively, install a two-level drain in the roof above adjacent to the crack.)
2. Replace the manhole cover.

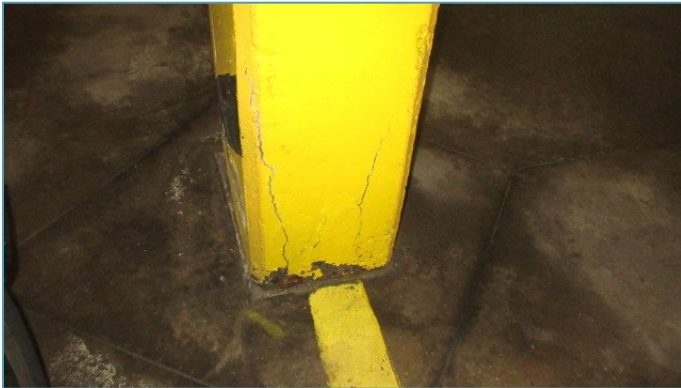
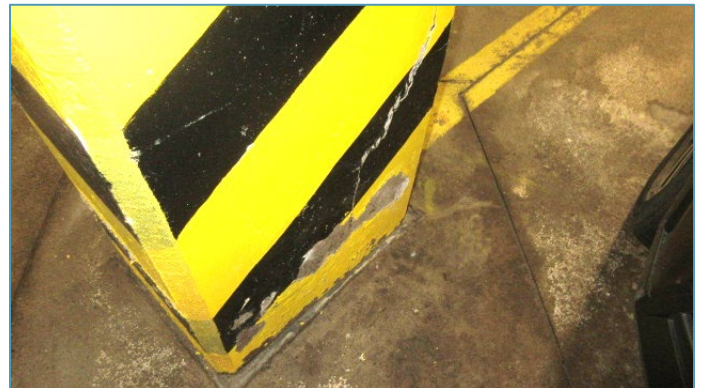
Four of the columns in the Basement Level which support the condominium building have diagonal cracks near the slab-on-grade level, most likely due to corrosion of the steel reinforcement in the columns where exposed to de-icing salts. These cracks have grown in the last five years and, while not yet of immediate structural concern, should be addressed.

Restore concrete locally at four columns by local replacement and/or injection grouting; clean and coat concrete with a waterproof sealant.

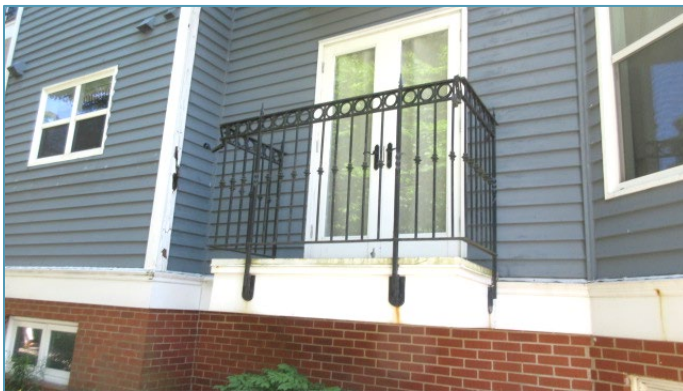
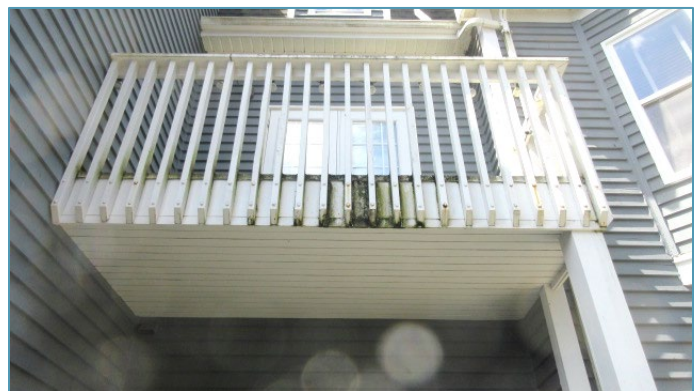
The balconies were not assessed in detail. Visually, from street level, they appear to be in good condition overall with staining from water retention of the decks.

Wood railings have been replaced at one unit and fascia boards have been replaced using an improved detail. One wood post has been replaced to date.

Based on the observed and reported condition and performance history, the balconies are assessed to have a remaining useful life of 10-15 years, on average.

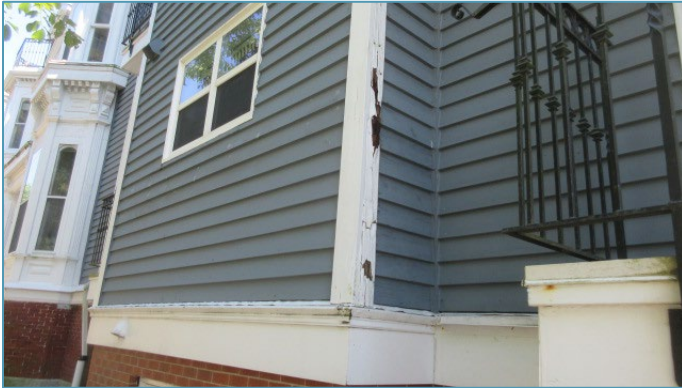
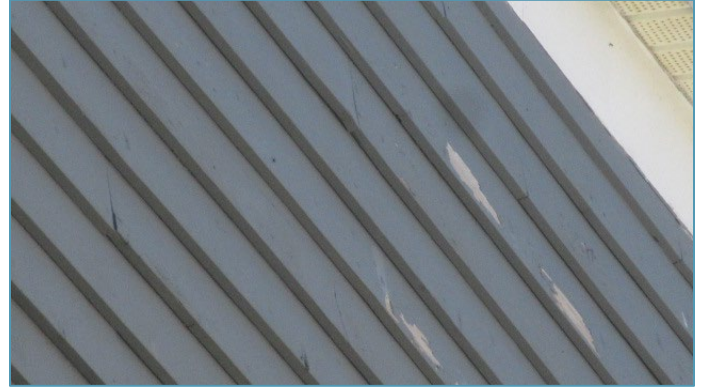
Most of the corner boards and trim are in good condition; however, there is local deterioration in several places.

Paint coatings are good overall on the south, west and north elevations, with local damage, and varied with local recoating and local loss of coating on the east elevation.

Repair all deteriorated wood and repaint 25% of walls and trim every two years.

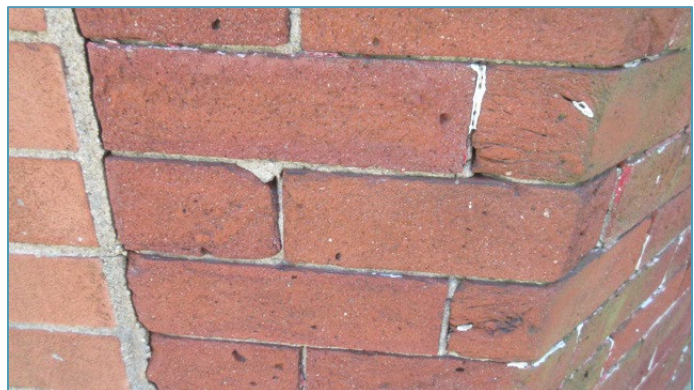
The tile is installed with 1/8" to 3/16" mortar joints which cannot retain standard masonry mortar. Mortar is missing in several places and has been replaced with caulking locally. The detail is, most likely, durable, but does not provide effective water resistance for the supporting foundation walls.

Within five years, repair locally by removing existing mortar and replacing it with a cementitious grout.

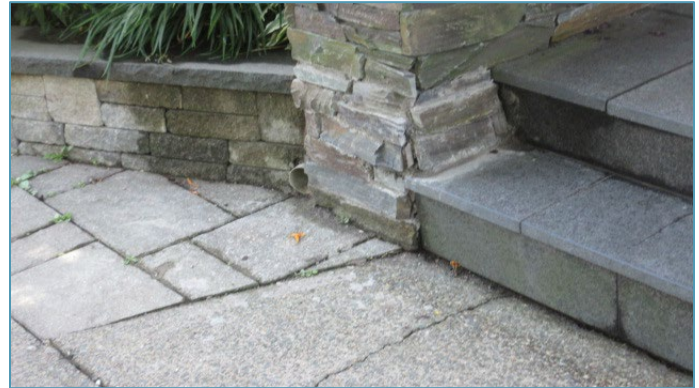
The stonework has deteriorated beyond repair.

Replace the stonework in the short term.

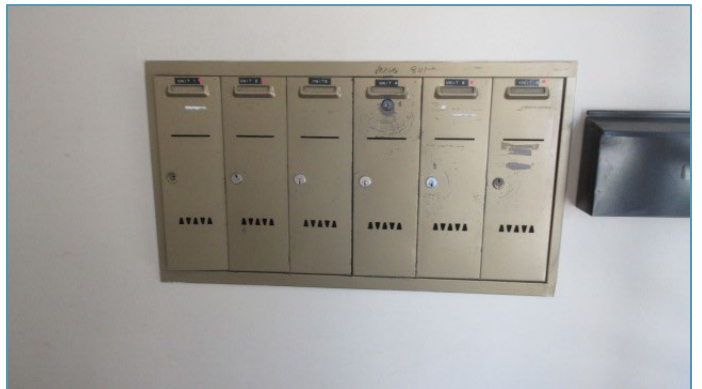
The mailboxes are worn, unreliable and a maintenance issue.

Replace mailboxes in 2025.

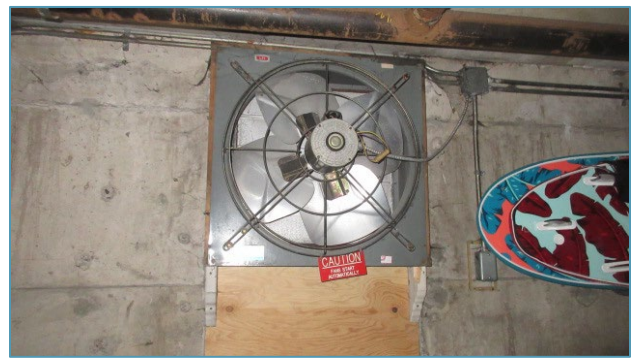
Sensors and controls for garage emergency ventilation were not identified in the assessment. No replacements have been noted in the past ten years.

Budget for replacing or installing sensors and controls for garage emergency ventilation.
