# RESERVE FUND STUDY

**1049 South Park Street**

Halifax County Condominium Corporation No. 144

March 12<sup>th</sup>, 2025

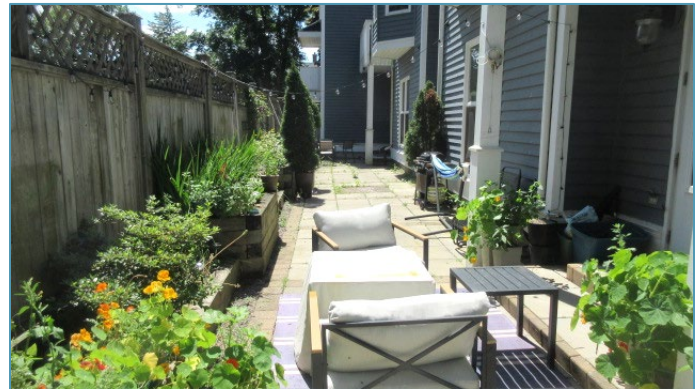
The flatwork is in good condition overall.

No replacement is anticipated during the evaluation period.

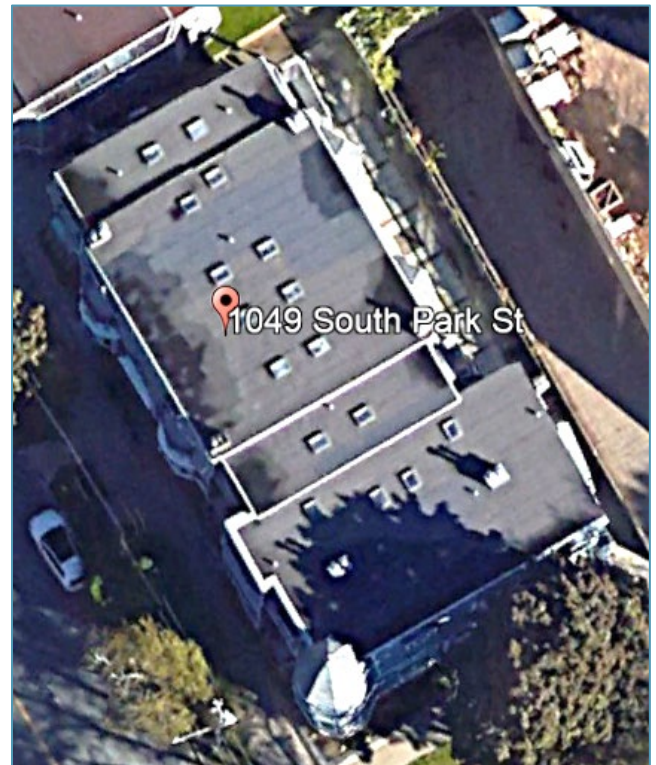
### MANSARD SHINGLES

Mansards and a turret are finished with standard residential asphalt shingles, replaced in the last five years.

The remaining life is assessed to be beyond the evaluation period.

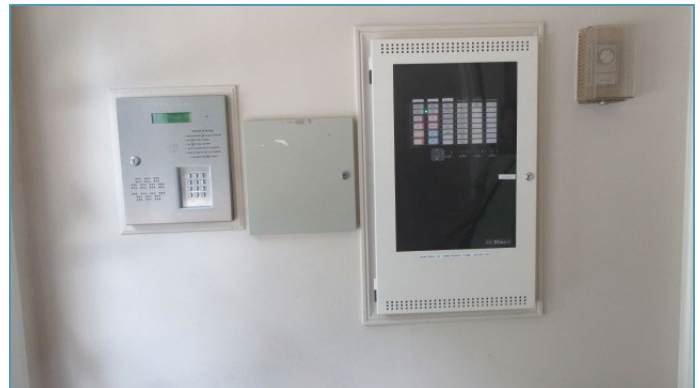
## ELECTRICAL/ELECTRONIC EQUIPMENT

The fire panel and alarms were replaced in 2018. The intercoms were replaced in the late 2010s.

In general, the expected useful life of the electrical and electronic fire protection control equipment is approximately 30 years. Smoke detectors and other sensors throughout the building are budgeted to be replaced as an annual maintenance item.

Budget for replacing the fire protection control panel and entry systems in 2045.
